PERFORMANCE OF TWO BORON-MODIFIED S-816 ALLOYS IN
A TURBOJET ENGINE OPERATED AT 1650° F

By William J. Waters, Robert A. Signorelli,
and James R. Johnston

Lewis Research Center
Cleveland, Ohio

March 1959

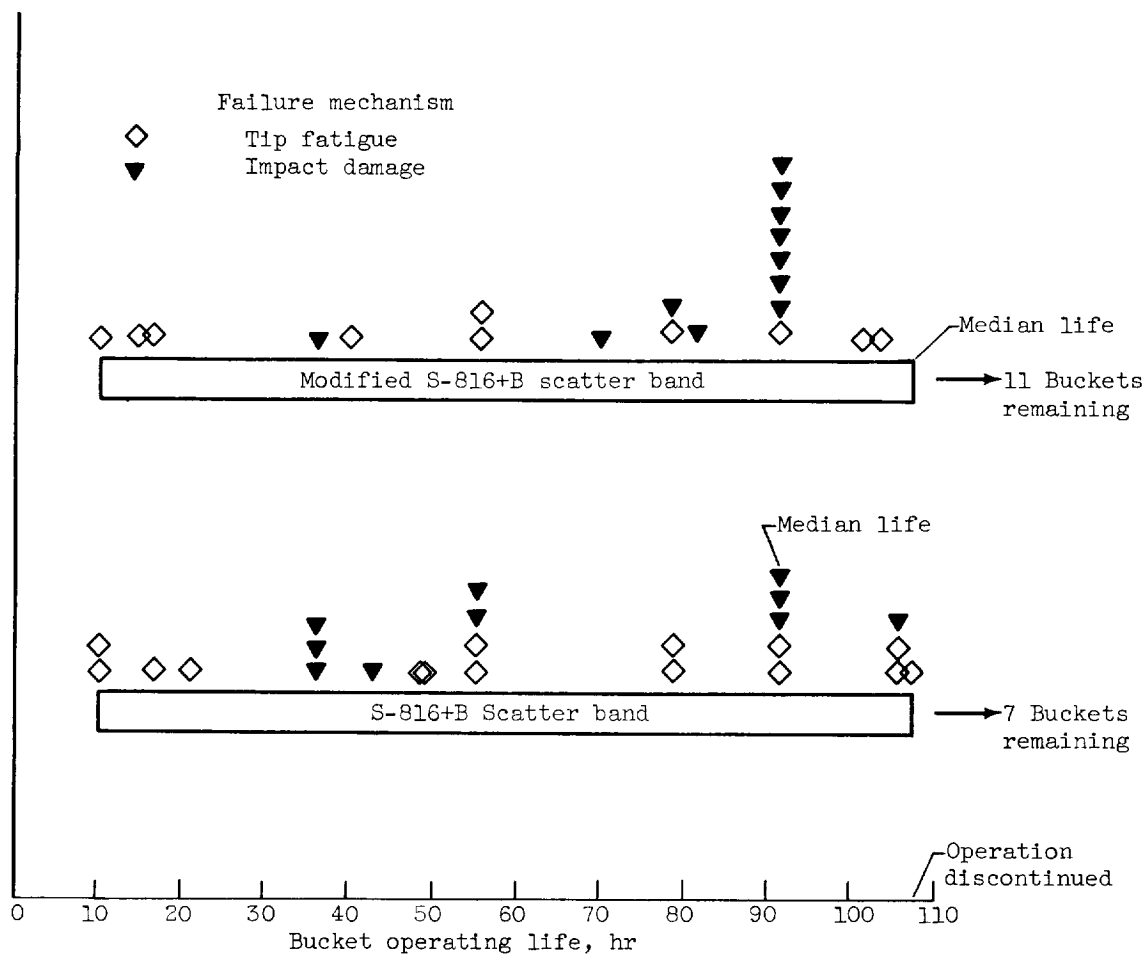
Figure 6 shows the failure times and mechanisms for turbine buckets of both alloys. Failures of both S-816+B and modified S-816+B buckets began after only 10 hours of engine operation and continued at various intervals throughout the test. The test was discontinued after $107\frac{1}{2}$ hours of operation, at which time 74 percent of the S-816+B buckets and 58 percent of the modified S-816+B buckets had failed.

Failures occurred by two mechanisms during the test. These were tip fatigue and impact damage induced in other buckets by the tip failures. The engine performance of S-816+B and modified S-816+B buckets was similar, although the modified S-816+B buckets appeared to be slightly superior on the basis of median life. In the computation of median lives, only bucket tip failures were included. Modified S-816+B had a median life of $107\frac{1}{2}$ hours, while S-816+B had a median life of $91\frac{1}{2}$ hours.

Figure 6. - Performance of S-816+B and modified S-816+B turbine buckets at 1650° F in J33-9 turbojet engine.

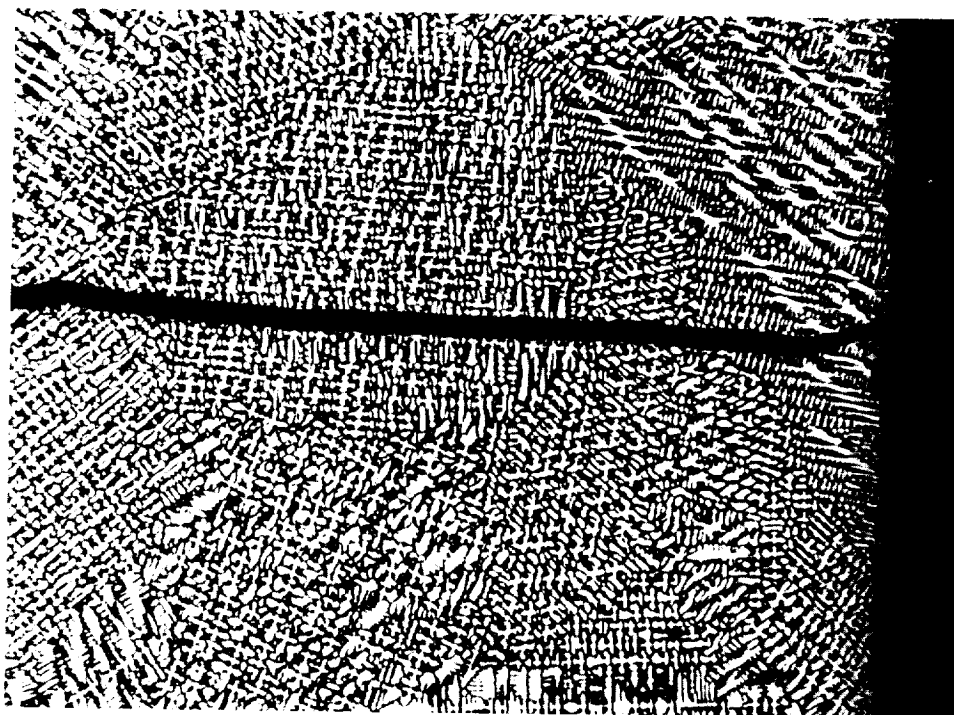
Microexamination revealed that the trailing-edge cracks were trans-crystalline, which is typical of those caused by mechanical fatigue. Figure 8 is a photomicrograph of a crack in a typical failed bucket.

Figure 8. - Typical trailing-edge fatigue cracks in engine-operated turbine bucket. Etchant, 20 cc water, 20 cc glycerine, 10 cc nitric acid, and 5 cc hydrogen fluoride.

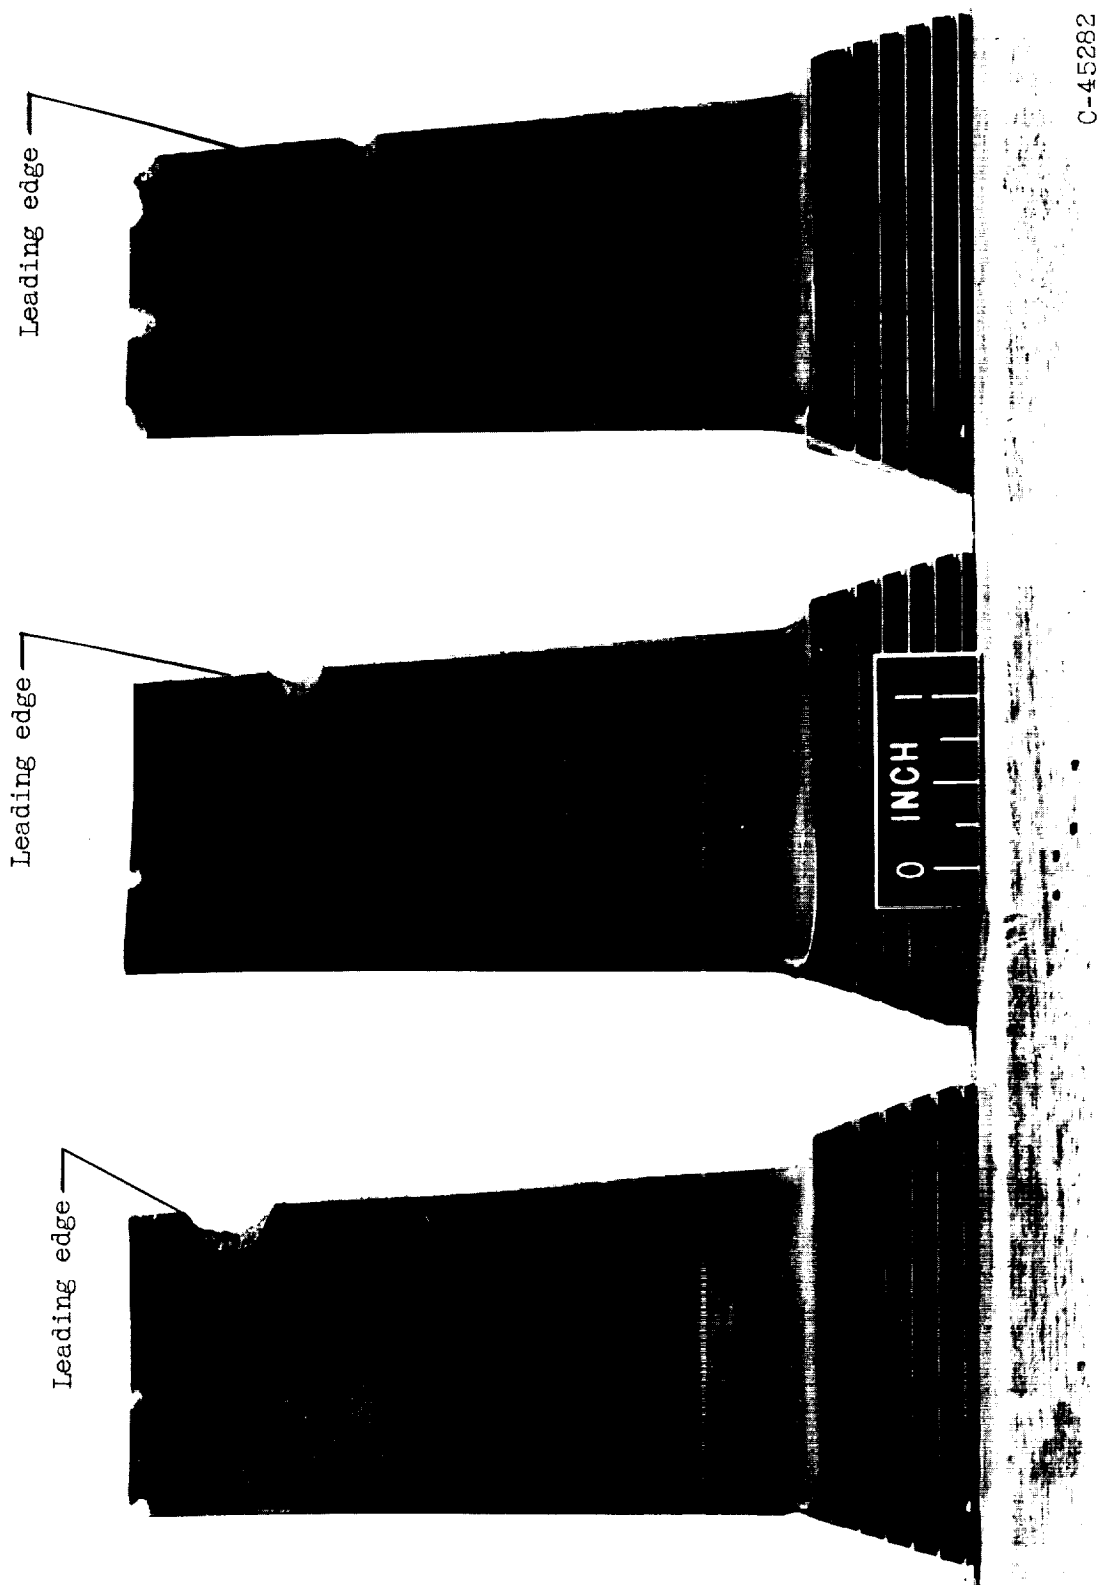
Impact damage accounted for numerous bucket failures of both alloys. The brittleness of both alloys is evident in figure 9, which shows typical impact damage. Twenty-one buckets were removed from the turbine wheel during the engine test because of this type of damage.

Impact damage was a secondary cause of bucket failures and was a direct result of bucket tip failures. The impact of small pieces of fractured bucket tips on surrounding buckets caused a relatively large amount of impact damage (fig. 9), as described previously.

The relatively large amount of impact damage is contrary to what might have been expected from the elongation data obtained from stress-rupture and tensile tests at 1650° F (fig. 13 and table II). These indicated considerable ductility. Also, the Izod impact tests at 1650° F (table III) indicated that the two alloys were only slightly weaker than Guy alloy in impact strength. While its impact strength was not particularly high, Guy alloy had displayed satisfactory impact resistance during engine operation (ref. 1), as noted previously. Possible inaccuracies in the laboratory test impact data due to the testing methods employed, as mentioned in the procedure section, could perhaps account for some deviation from expected behavior. A more reasonable explanation of the apparent anomaly might be made if more were known about the effect on impact resistance of the impact velocities in the engine and those encountered in the test apparatus. The impact resistance of the S-816+B alloys may have been more adversely affected by increased impact velocity than was the impact resistance of Guy alloy. Perhaps the room-temperature low-velocity laboratory impact tests of the alloys provide a better indication of their relative impact resistance under elevated-temperature high-velocity engine impact conditions than do elevated-temperature low-velocity laboratory tests. As noted earlier, the room-temperature impact strengths of the two S-816+B alloys were about half that of Guy alloy (table III). If the foregoing postulation were valid, the impact damage observed in the engine tests with the two S-816+B alloys as compared with Guy alloy would be reasonable.

Figure 9. - Typical impact damage to buckets after engine operation.

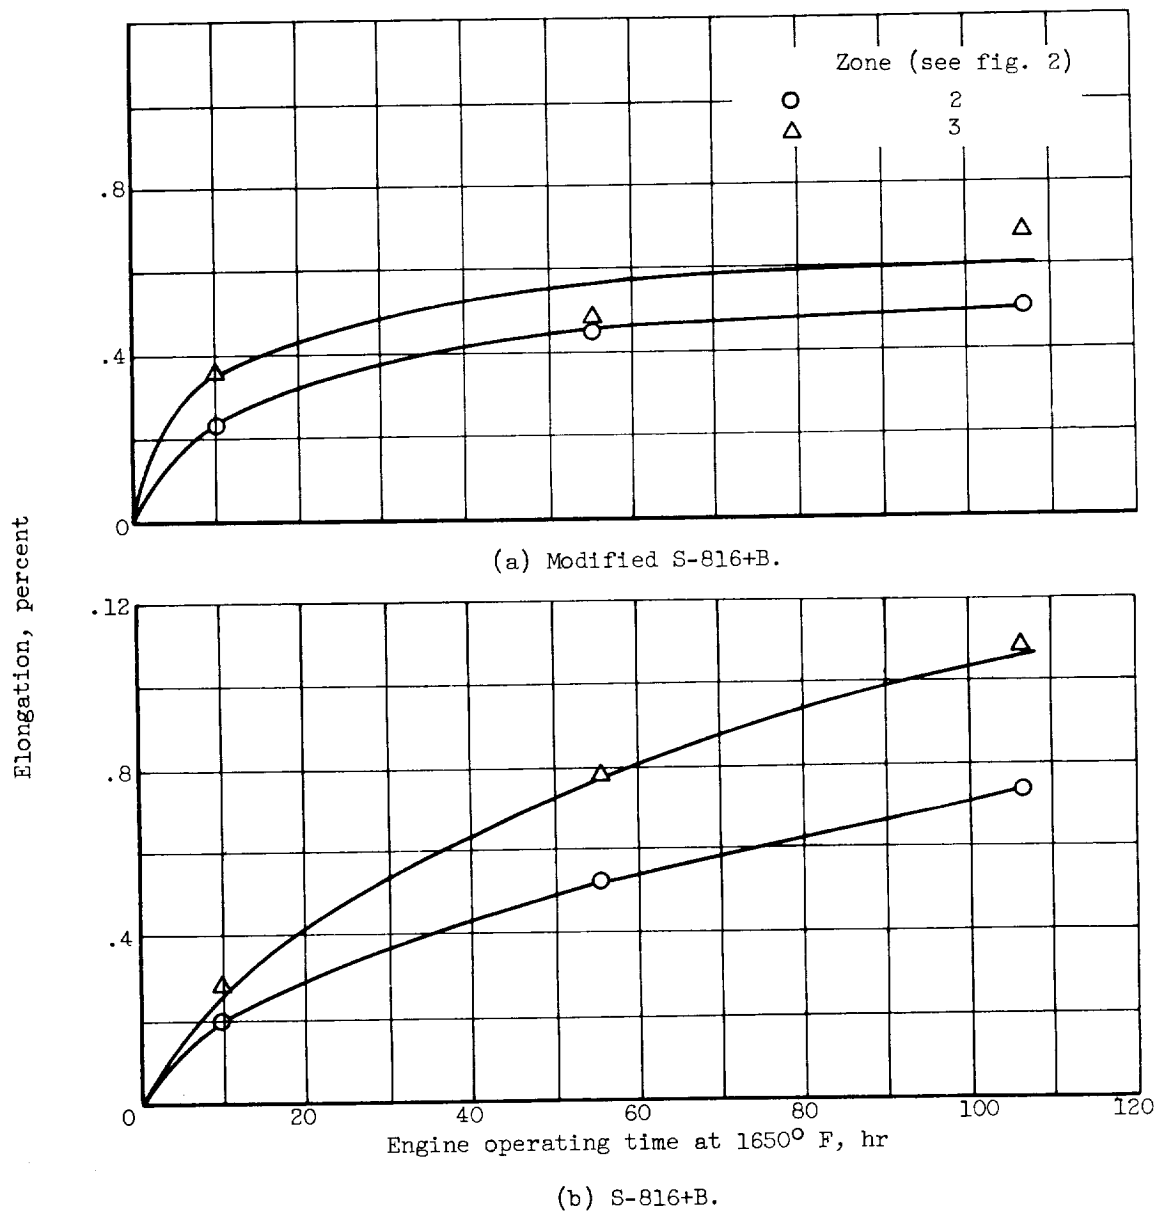
Of the six buckets scribed for elongation measurements, only one of each alloy remained in operation for the entire test. The others had previously been removed because of failure. Figure 10 shows the elongation of the two central zones of the two bucket airfoils during 106 hours of operation. The S-816+B airfoil showed a maximum elongation of 1.1 percent in zone 3. This is greater than the elongation of the modified S-816+B bucket, which elongated approximately 0.7 percent in the same zone.

Figure 10. - Elongation rate of midchord section of bucket airfoil.

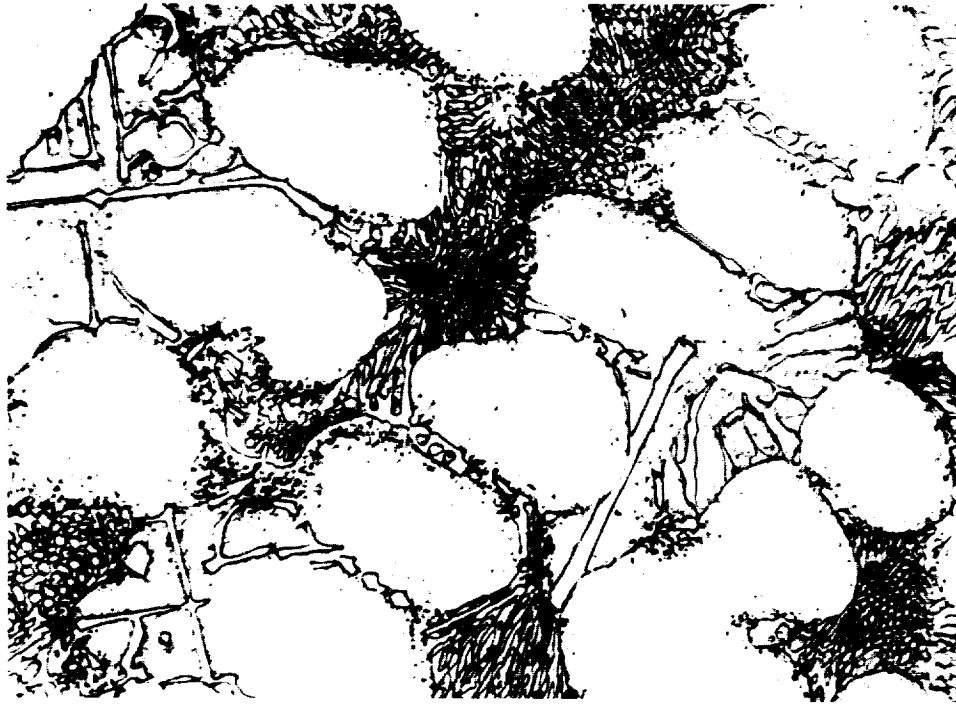
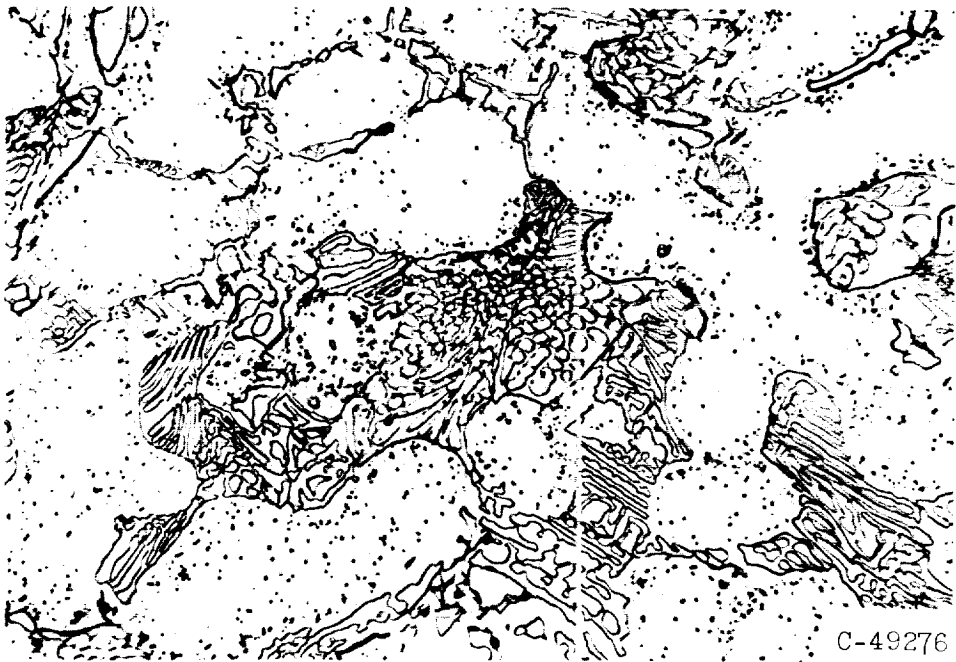
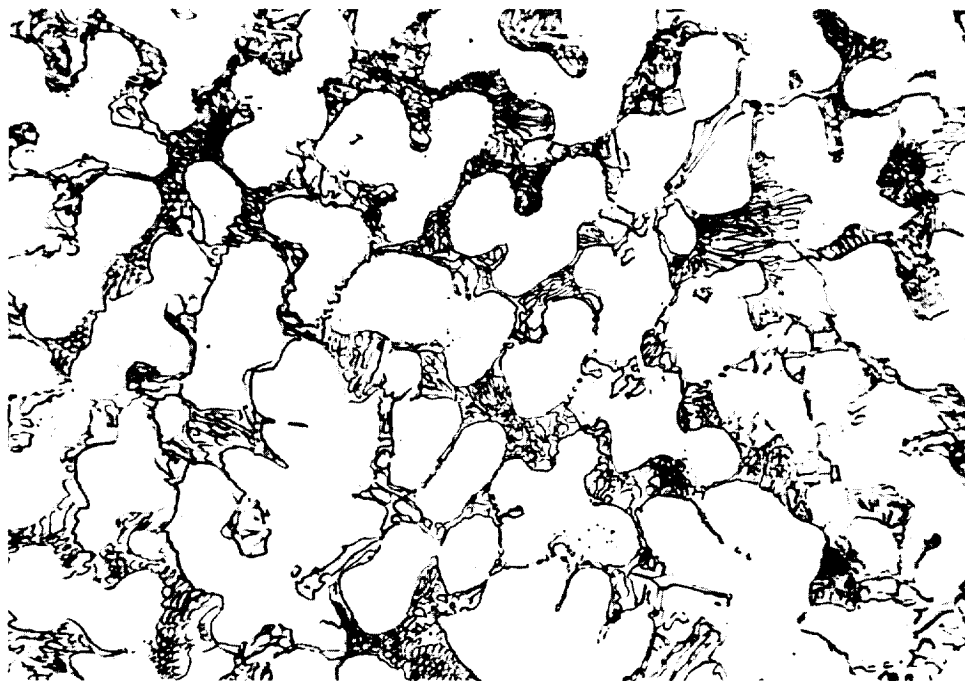
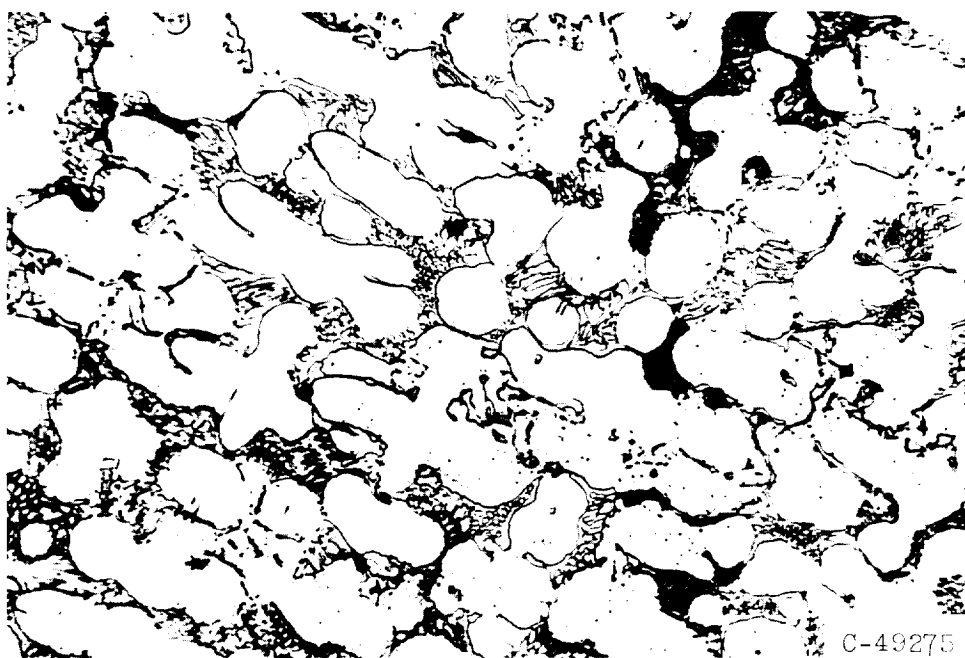
Photomicrographs of engine-operated buckets of both alloys are shown in figure 12. Precipitation in the matrix increased with increased engine operating times at 1650° F. Modified S-816+B appears to be the more stable of the two alloys in that precipitates apparently formed at a slower rate.

Figure 12. - Effect of 1650° F engine operation on alloys.
Etchant, 20 cc water, 20 cc glycerine, 10 cc nitric acid,
5 cc hydrogen fluoride. X750.
